DOT/FAA/AR-03/46

Damage Tolerance and Durability of Selectively Stitched, Stiffened Panels

June 2003

Final Report

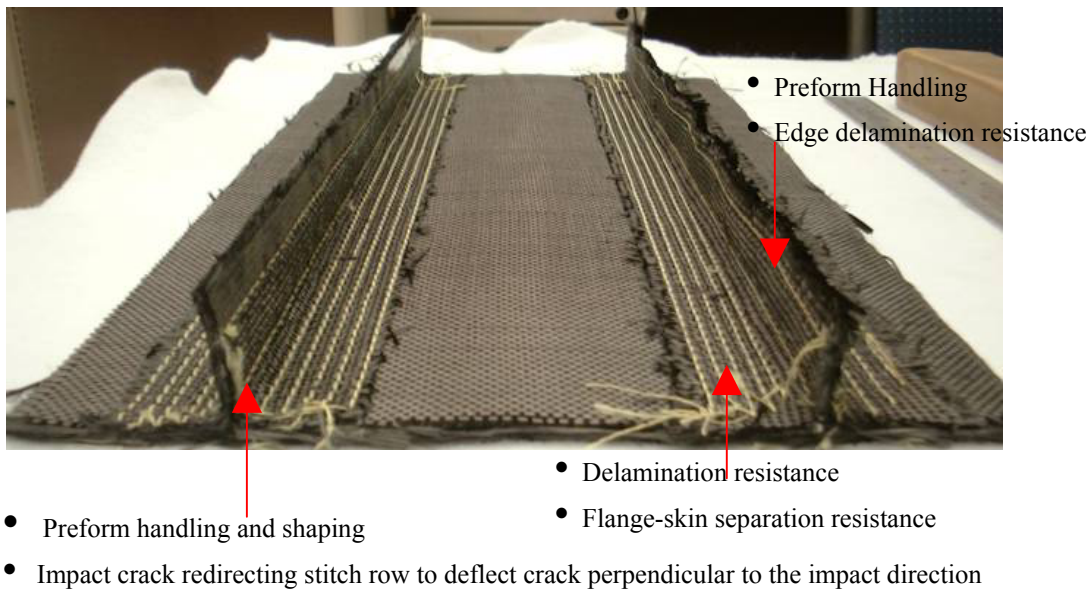
FIGURE 1. SELECTIVELY STITCHED PREFORM WITH STIFFENERS

Fiber preforms for the selectively stitched, stiffened panels were prepared as follows. On the flange skin adjoining region, selective stitching was used to prevent stiffener separation under skin buckling and to form a near-net shape of the stiffened panel, as in the fully stitched panel. The stitch density in the selectively stitched panels was reduced to 2.48 stitches per cm² to investigate the effect of stitch density on the compression strength of undamaged panels and on the impact damage area. In the stiffener region, stitching was minimized for the selectively stitched panels. A minimal amount of stitch row was used for handling and to prevent edge delamination at the top of the stiffener. In addition, a stitch row near the start of the stiffener was used to investigate if the impact crack propagation could be deflected. The selectively stitched conditions are summarized in table 2, and the resulting stitched fabric preforms are shown in figure 1.

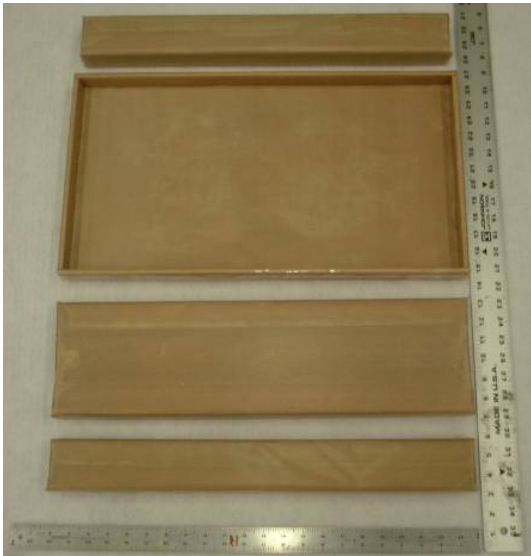
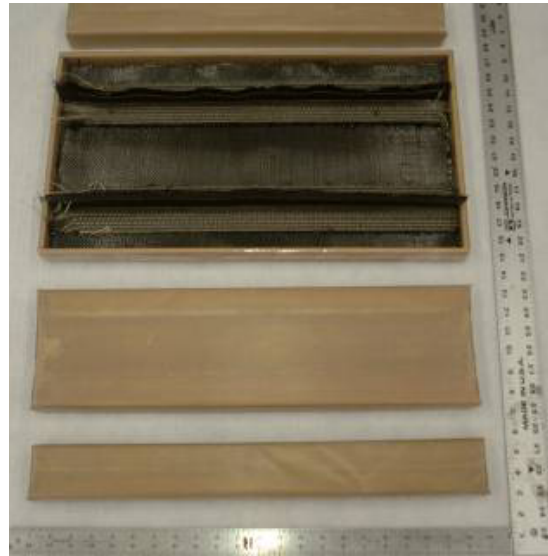
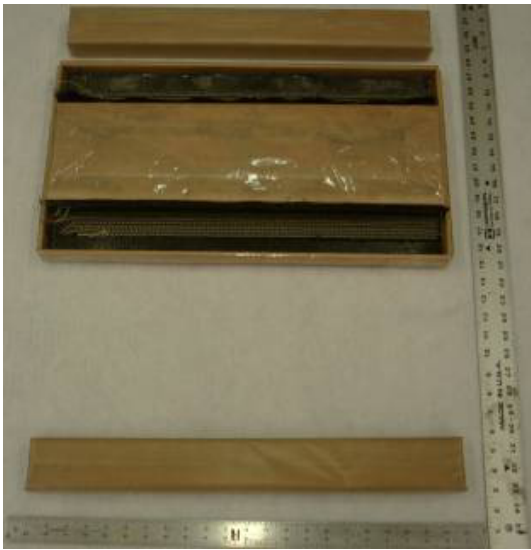
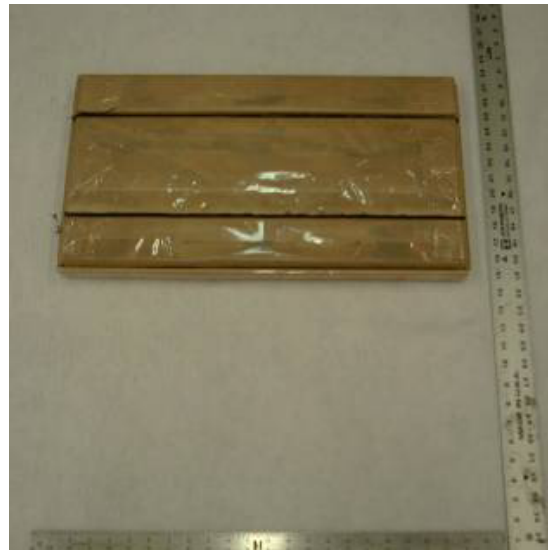
FIGURE 3. MOLD PREFORM ASSEMBLY

thickness of the two stiffeners. Each of the mold parts was treated with a release agent and covered tightly with a nonporous Release Ease 234 peel ply using a high temperature adhesive tape. The mold preform assembly is shown in figure 3.

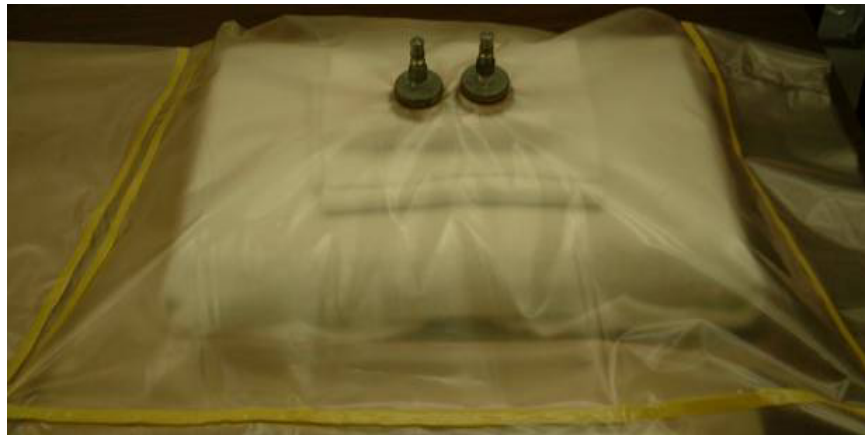
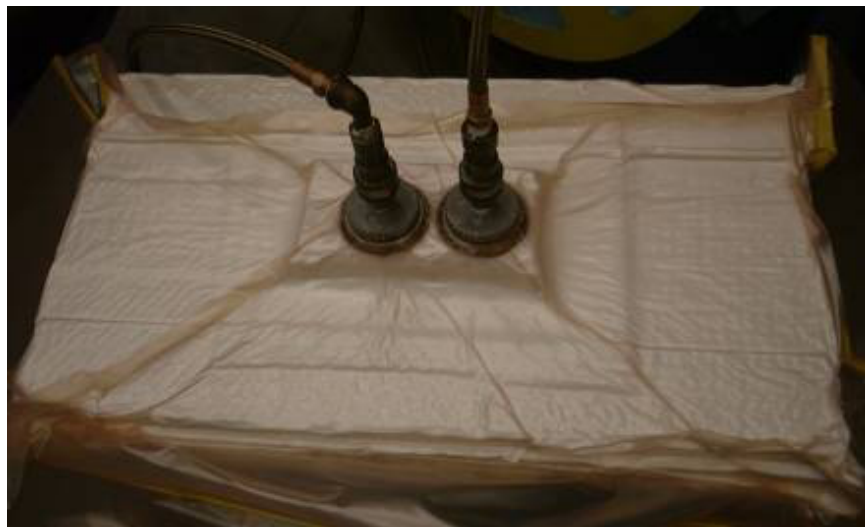
FIGURE 4. VACUUM BAGGING AND LEAK TEST

The selectively stitched preform was placed into the mold containing the resin film, pressed down using a roller, and the inner molds were put into place. Four bleeder plies approximately 8 by 15 cm were placed on center where two vacuum ports were to be located. A rectangular steel frame covered with a porous ply was inserted to keep the vacuum ports and the bleeder plies apart to avoid resin flow into the vacuum ports. Two layers of Airweave breathers were used to cover the topside, and the entire assembly was vacuum bagged using IPPLON DP-1000 and sealed around the edges with a sealant tape. After attaching two vacuum lines, a leak test was performed, as shown in figure 4.

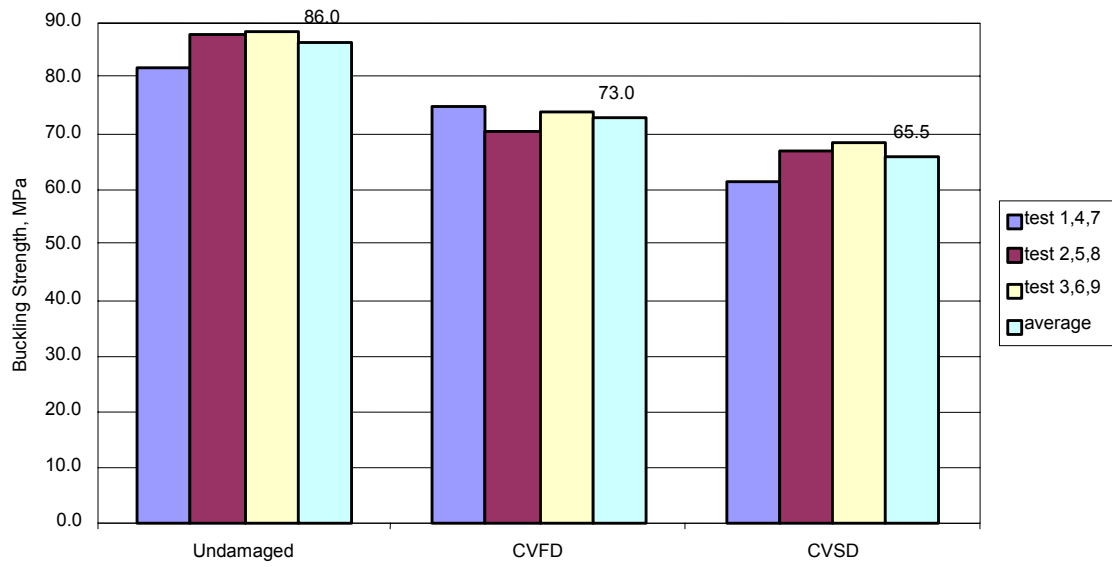
FIGURE 5. BUCKLING STRENGTHS OF SELECTIVELY STITCHED PANELS

The individual test data on the selectively stitched panels are summarized in table 4. As shown in figure 5, the average buckling strengths of selectively stitched panels for undamaged, CVFD, and CVSD are 86.0 MPa, 73.0 MPa, and 65.5 MPa, respectively. The impact damage on CVSD panel no. 7 was more than expected; this resulted in a lower buckling strength. Other than panel no. 7, a fairly consistent buckling strength was observed. A wider experimental scatter was observed for CVSD panels due to differences in stiffener damage incurred on each panel. Additional information on the manufactured panel quality for selectively stitched panels is summarized in table 5. The undamaged and CVFD results are also seen to be fairly consistent. Buckling strains measured by a center strain gage are shown in figure 6, while the elastic moduli calculated from the measured strains are shown in figure 7. On average, undamaged and CVFD panels buckled at a strain value of 2130 μ strain and 2010 μ strain, respectively, whereas CVSD panels buckled around 1720 μ strain. The initial compressive moduli remain fairly consistent with the average value of 40.3 GPa, 38.6 GPa, and 38.1 GPa for undamaged, CVFD, and CVSD, respectively. The failure strengths of the same panels are shown in figure 8. The reported values for the average failure strengths of undamaged, CVFD, and CVSD panels are 166.3 MPa, 157.7 MPa, and 132.0 MPa, respectively.

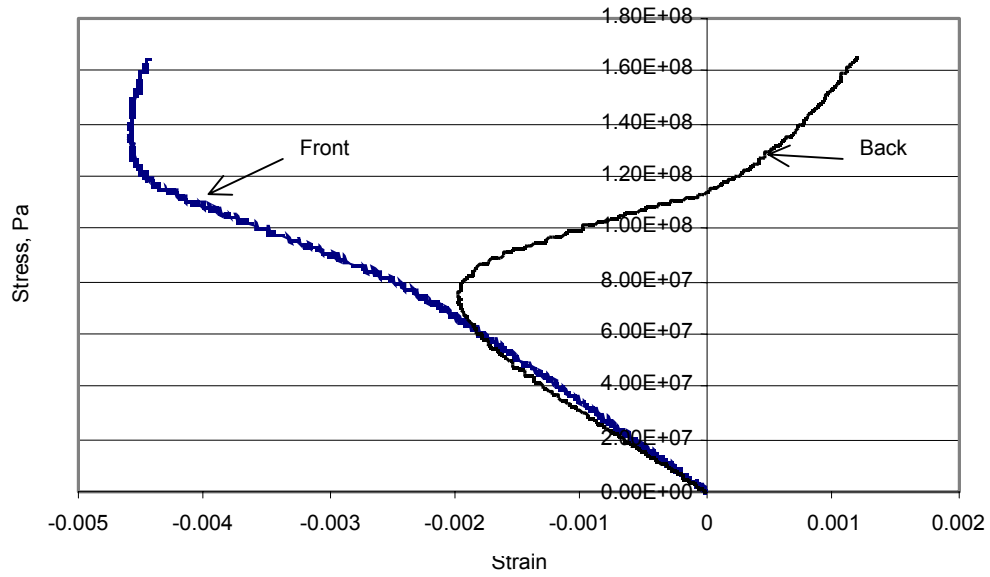
FIGURE 11. LOAD-STRAIN PLOT OF SELECTIVELY STITCHED, STIFFENED PANEL:
UNDAMAGED

As shown in figures 11 and 12, the strain plots of selectively stitched and unstitched panels closely resemble each other for both the skin (front) and stiffener (back) side strains during loading. The only difference is that the back side strain value is extended for the selectively stitched panel, hence, the failure strength increased for this panel. Prior to a failure, there is a relaxation or stagnation in the strain value for both unstitched and selectively stitched panels. As shown in figure 13, the skin side strain history for the fully stitched panel resembles those of selectively stitched and unstitched panels. However, the stiffener side strain differs in that it increases bilinearly until failure.

damage are as shown in figure 22, and is similar to those of the undamaged, figure 11, or the flange-impacted panels, figure 16. The unstitched panels show a similar trend. That is, less severe impact damage does not change the resulting strain plot to any substantial extent, as indicated by test 7 with figure 23. Note that figure 23 resembles the strain plot of unstitched, undamaged panels. All other test panels with severe impact damage, including the fully stitched panel, had strain plots similar to the one in figure 24. All the fully stitched panels suffered severe damage to the stiffener upon impact, as indicated by their strain plots.

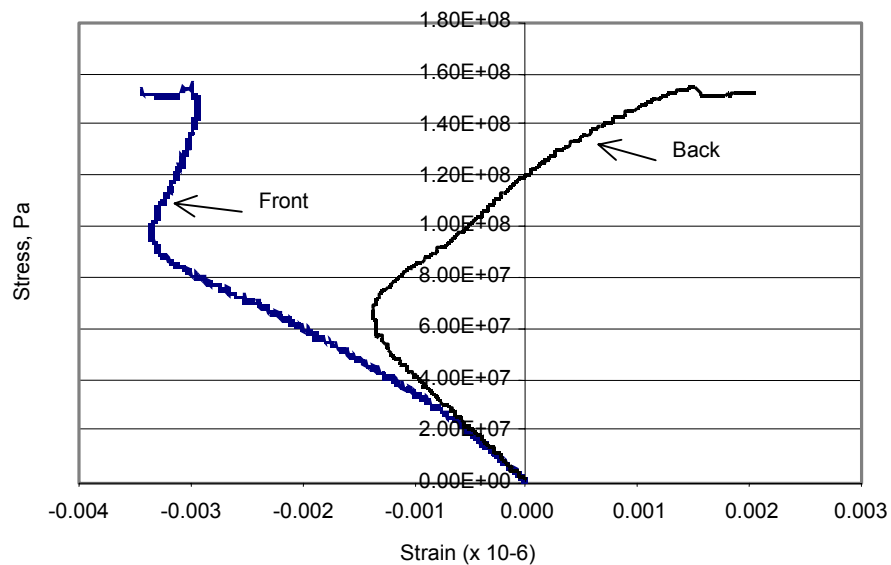
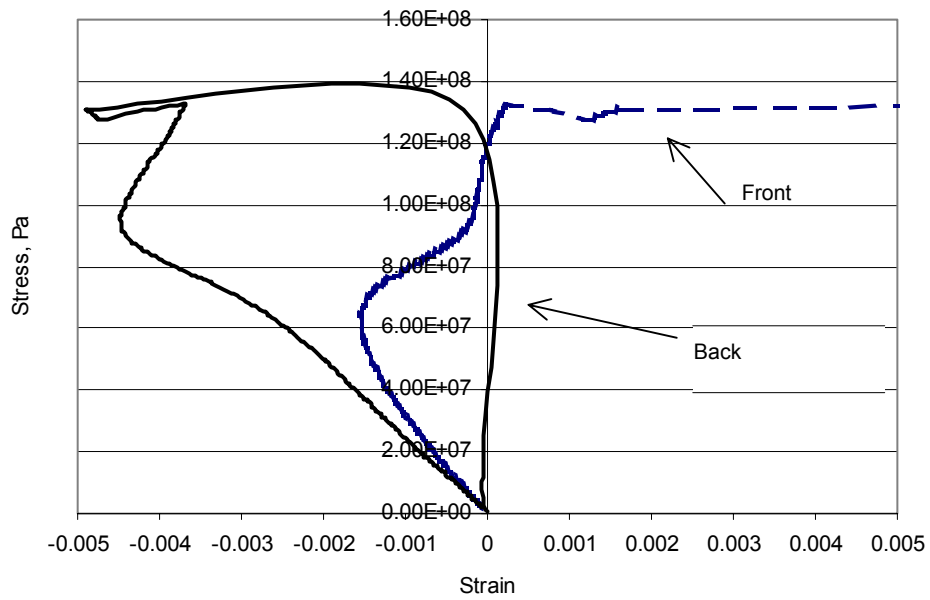
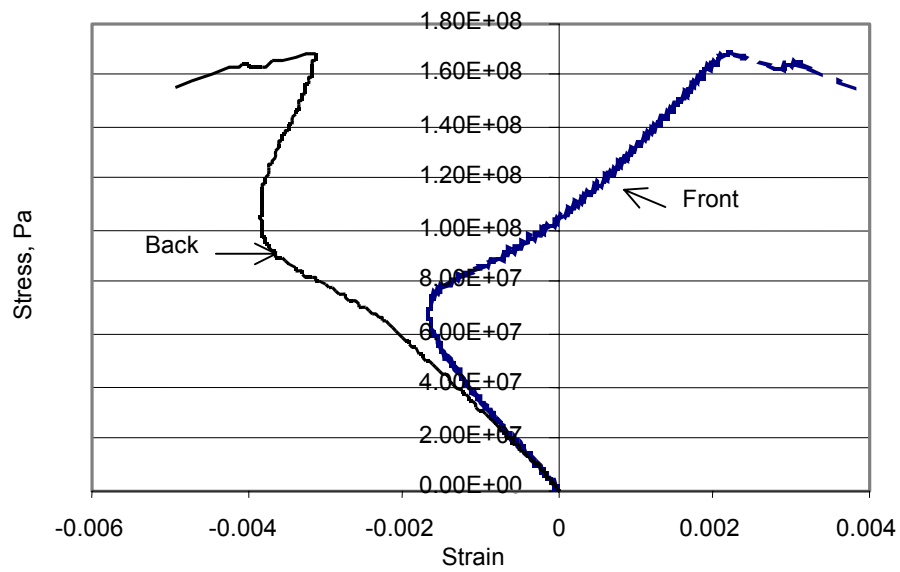
As shown in figures 16 through 18, the strain plots at the panel center during the loading resemble each other in that their shapes are quite similar. One obvious difference is that the failure strength increased with increased stitch density. The other difference is observed for the skin (front) side strain history. Near the 100 MPa stress level, the unstitched panel stress rises asymptotically, whereas the strain for the stitched panels continued as before. When the stiffener side (back) strain is considered, it indicates strain relaxation for all the panels alike. The source for this anomaly is uncertain. One possible explanation is that the strain relief is due to an unimpeded advancing crack in the unstitched panel. Another explanation is that the stiffener close to the impact in unstitched panel fractures ahead, leading to a different mode shape at

failure. Ultimately, the unstitched panel had the lowest compression strength as summarized in table 11.

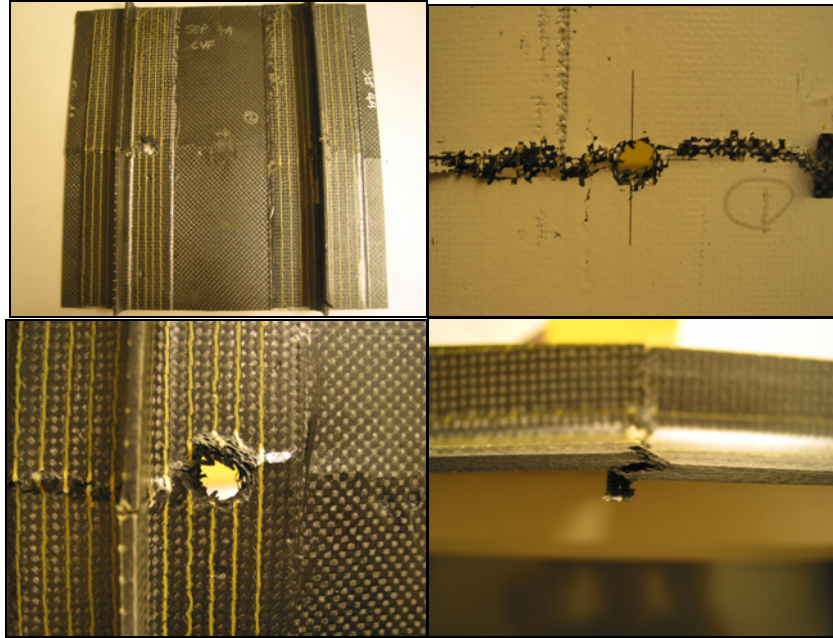
FIGURE 19. FAILED SPECIMEN (SEP4a): FLANGE-IMPACTED, SELECTIVELY STITCHED

As shown in figure 19, typical failure occurred due to a crack extension from the impact site that migrated bilaterally, and failure was imminent when the crack had extended into a stiffener. In terms of percentage increase in strength compared to the unstitched panels, the failure strength increased by 15.9% on average with 2.48 stitches per cm^2 and 18.8% with 9.92 stitches per cm^2 .

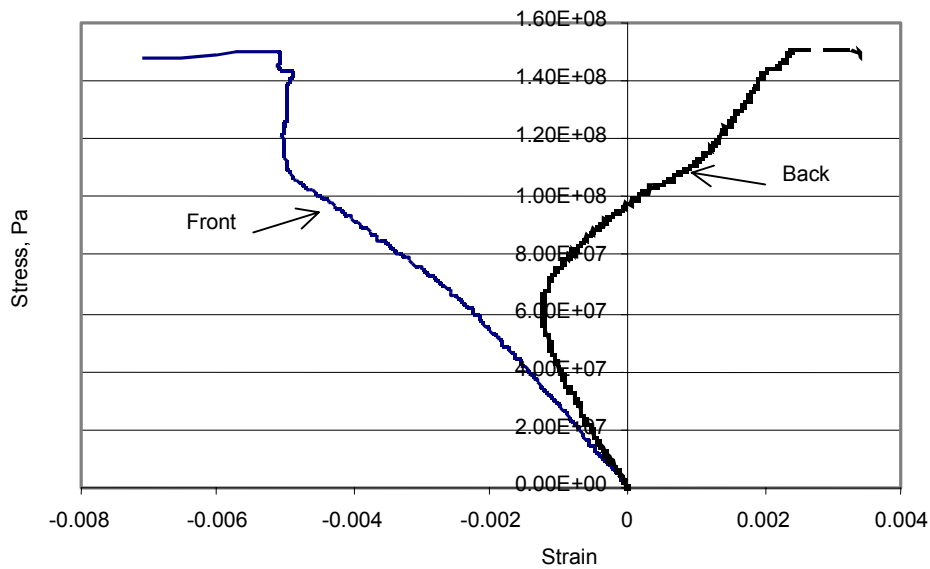
FIGURE 22. LOAD-STRAIN PLOT OF SELECTIVELY STITCHED, STIFFENED PANEL: STIFFENER DAMAGED

Strain plots of the stiffener-damaged panels vary significantly, depending on the severity of the damage. For the selectively stitched panels, strain plot, typical of tests 8 and 9, with less severe

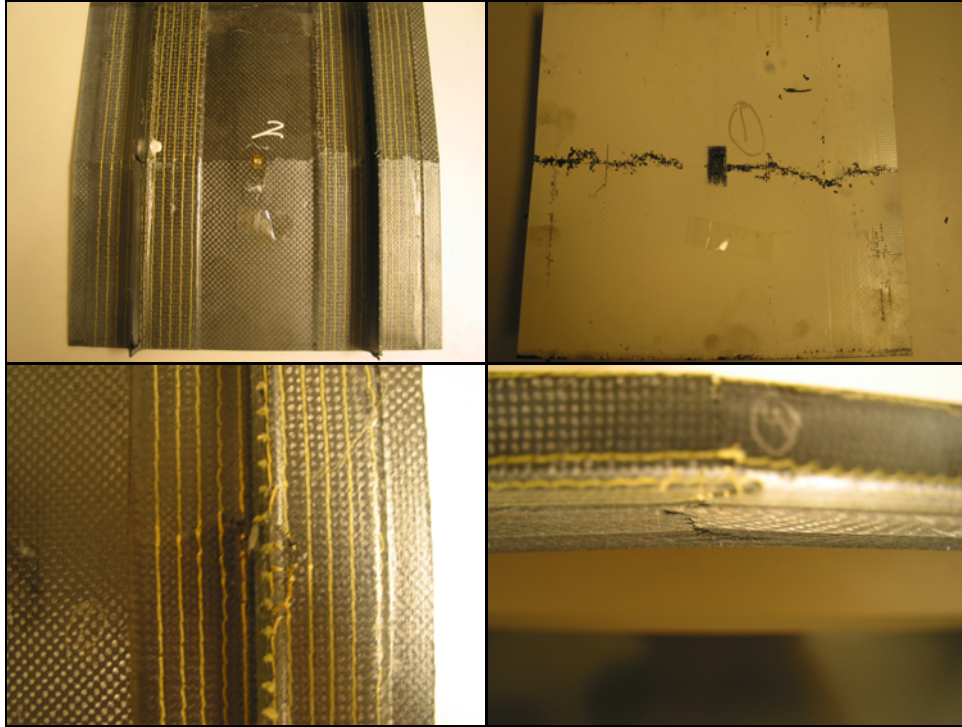
FIGURE 25. FAILED SPECIMEN (SEP1a): STIFFENER-IMPACTED, SELECTIVELY STITCHED

Figure 25 shows the typical final failure for the selectively stitched, stiffener-impacted panels. The crack extended bilaterally from the stiffener impact site, and the stiffener cripples once the crack extended approximately 25.4 mm. Immediately, the load was transferred to the other stiffener and that stiffener fractured. The final failure of the other types of panels were similar.

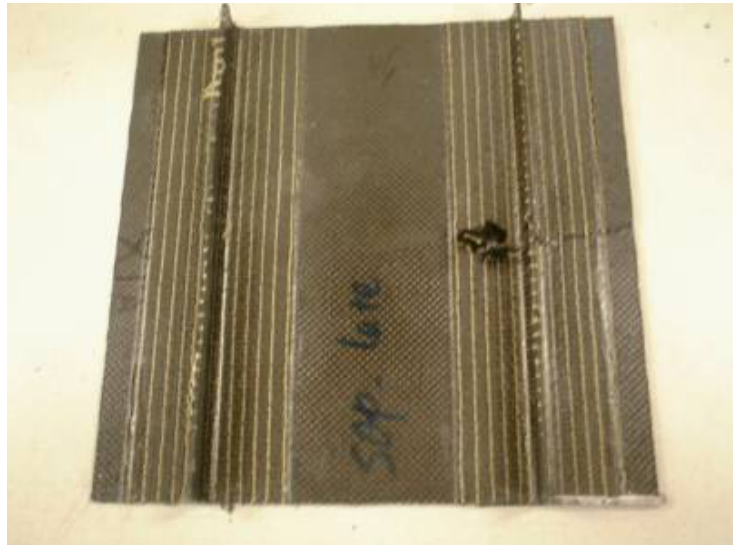
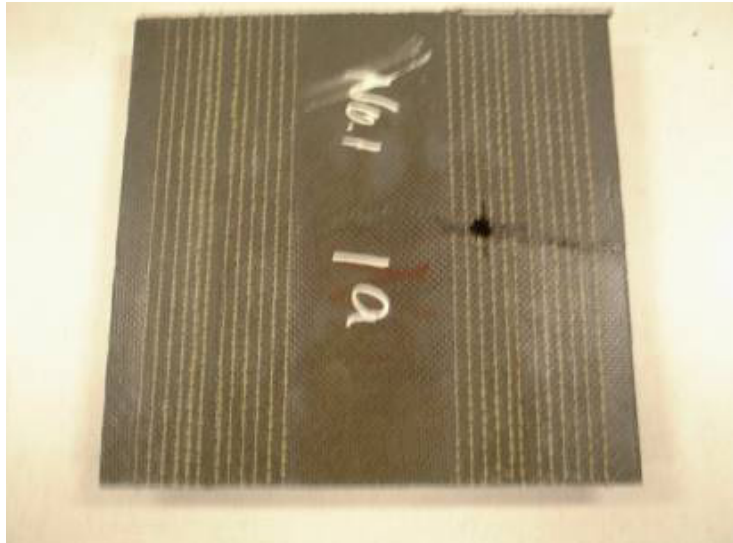
FIGURE 26. PANEL SEP6a POSTFATIGUE

At the first stress level (135.3 MPa), two selectively stitched panels, Sep6a and Sep9a, were tested. Panel Sep6a failed at 225 cycles with the cracks extending from the impacted region, whereas panel Sep9a failed at 364 cycles due to a stiffener failure away from the impact site. The difference in the failure modes is due to the difference in the impact damage. Panel Sep6a had typical penetration damage (figure 26), whereas panel Sep9a did not have penetration damage (figure 27). The sizes of the impact damage on panels Sep6a and Sep9a were measured to be 12.7 mm and 10.0 mm, respectively. It is interesting that the differences in the number of cycles to failure are not that much different.

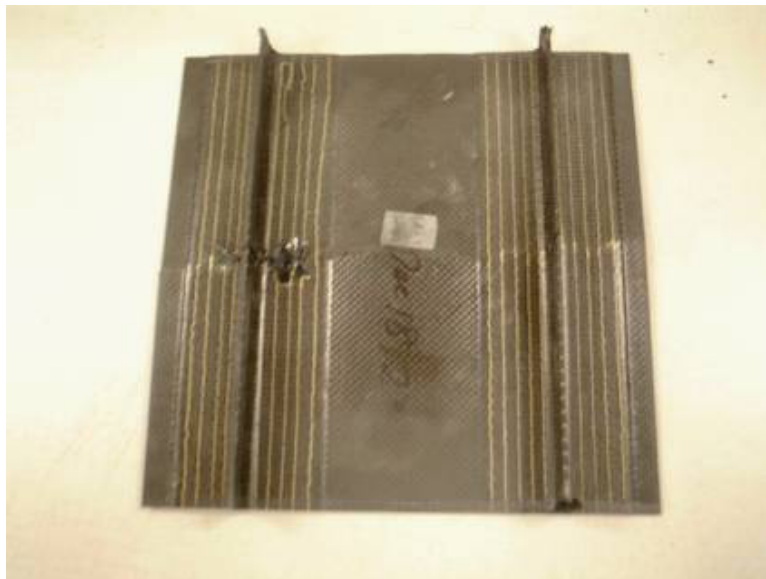
FIGURE 28. PANEL SEP7a POSTFATIGUE

At the second stress level (130.1 MPa), two selectively stitched panels, Sep7a and Sep16b, were tested. Panel Sep7a failed at 4013 cycles with cracks extending from the damaged sites similar to panel Sep6a but the crack line extended across the entire panel, as shown in figure 28. The damage size of panel Sep7a was equivalent to panel Sep6a. Panel Sep16a failed at 982 cycles; figure 29 shows the failed panel.

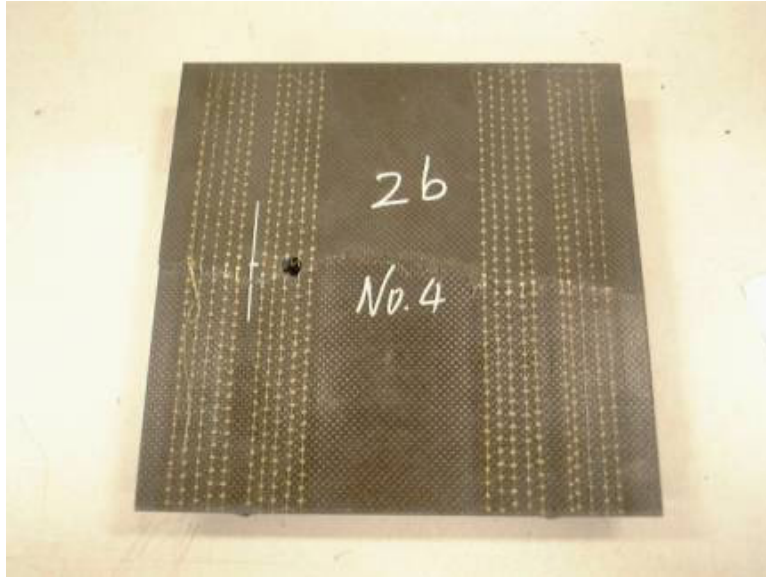
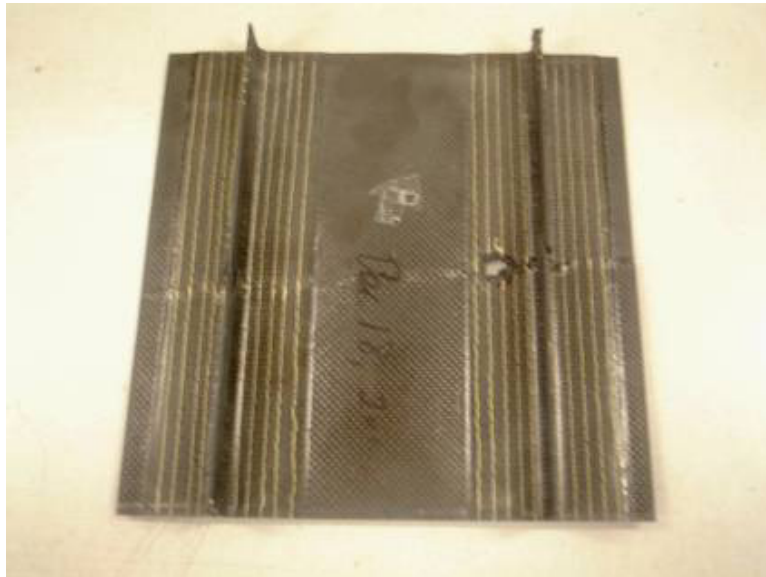
FIGURE 30. PANEL SEP7b POSTFATIGUE

At the third stress level (119.7 MPa), three selectively stitched panels, Sep7b, Sep9b, and Sep10b, were tested. Panel Sep7b failed at 14,164 cycles, and as shown in figure 30, its crack extension mode and damage size was similar to panel Sep7a tested at a higher stress level. Similar to test panel Sep9a, panel Sep9b failed at 2279 cycles due to a stiffener failure away from the damaged site, as shown in figure 31. Panel Sep9b also showed a nonpenetrating impact. Panel Sep10b failed at 5362 cycles similar to panel Sep7b with cracks extending from the damaged site; figure 32 shows the postfatigue photo.

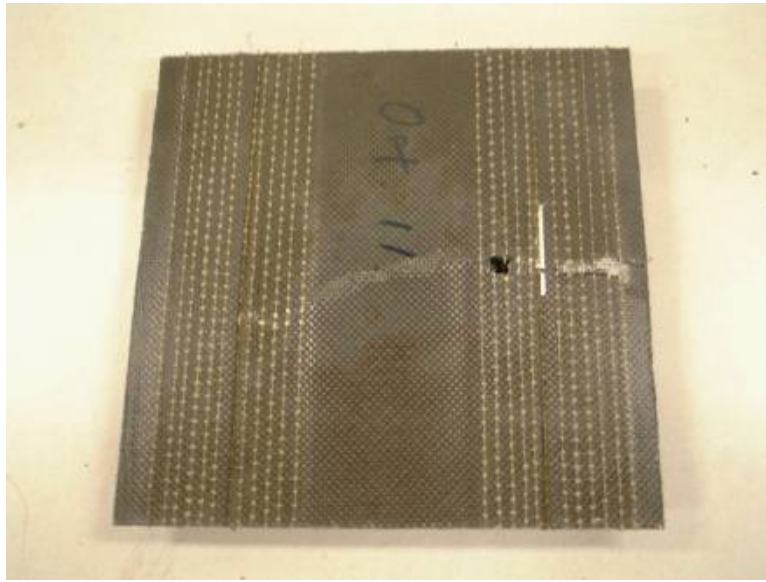
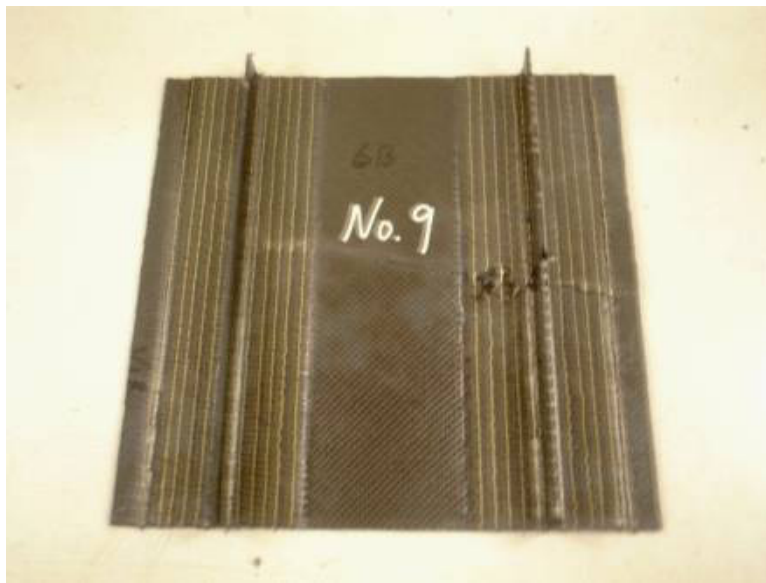
FIGURE 34. PANEL SEP8a POSTFATIGUE

At the fourth stress level (111.9 MPa), two selectively stitched panels, Sep8a and Sep10a, were tested. Panel Sep10a failed at 896 cycles, lower than panel Sep10b, tested at a higher stress level of 119.7 MPa, even though the failure mode and damage characteristics were similar, as shown in figure 33. Panel Sep8a failed at 16,126 cycles, with clean damage penetration, as shown in figure 34.

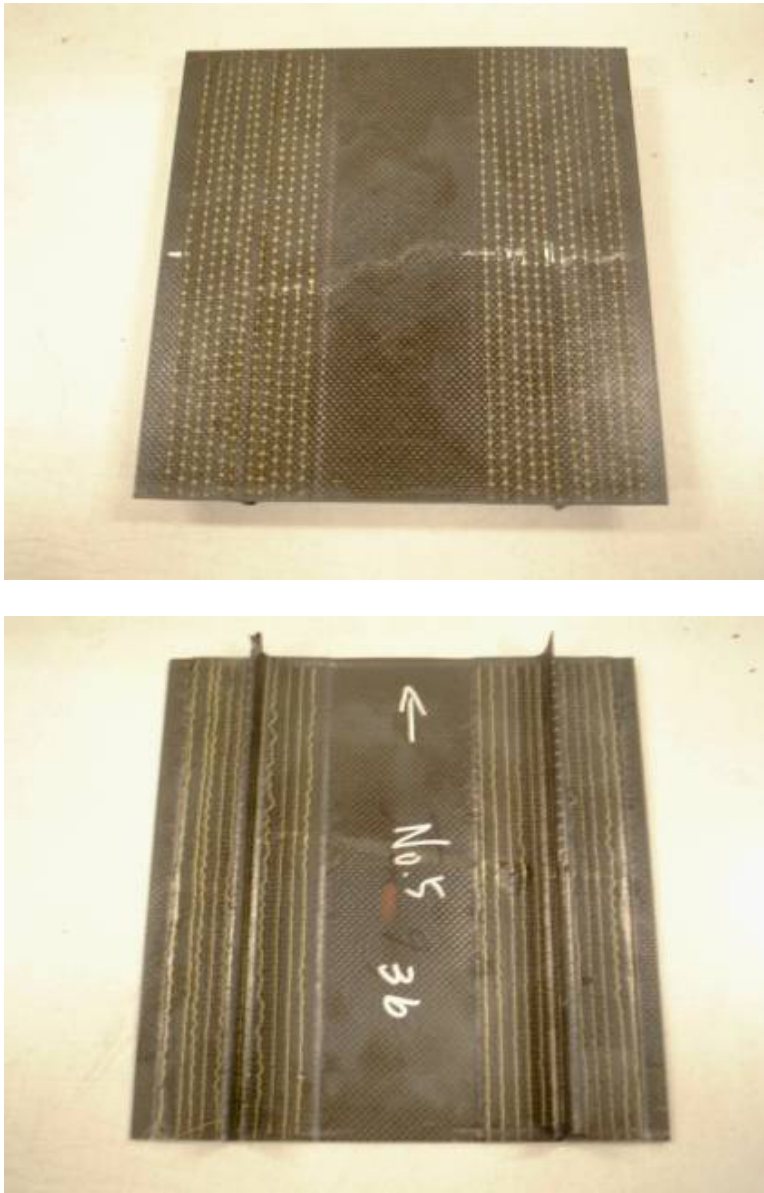
FIGURE 35. PANEL SEP8b POSTFATIGUE

At the fifth stress level (103.6 MPa), two samples of selectively stitched panels, Sep8b and Sep11a, were tested. Figures 35 and 36 show panel Sep8b suffered visually much less impact damage than panel Sep11a. However, panel Sep11a failed at 87,934 cycles, whereas panel Sep8b failed after 6037 cycles.

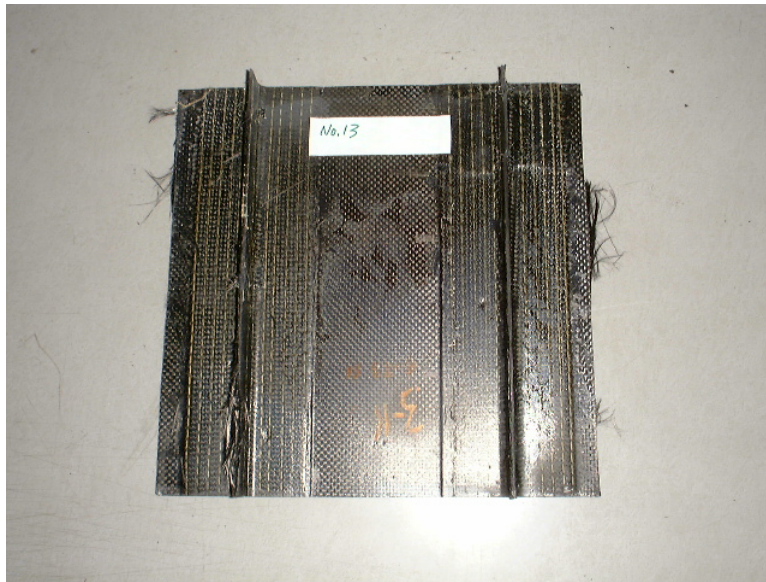
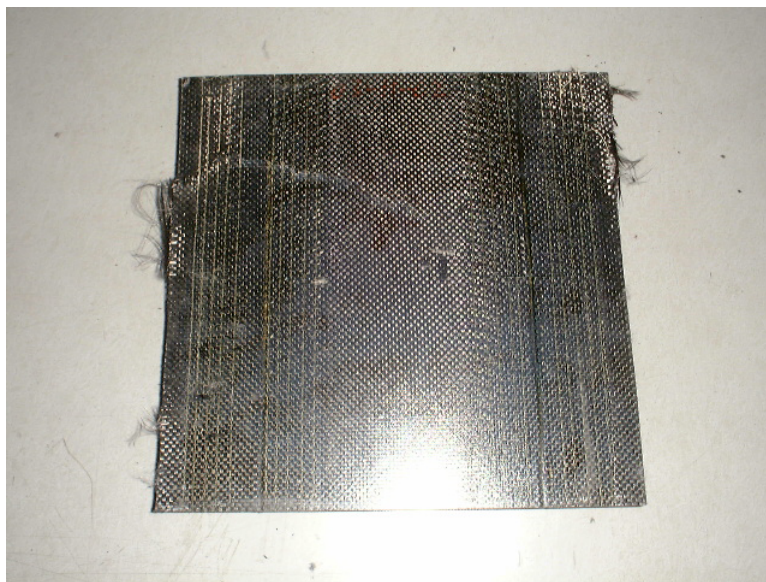
FIGURE 38. PANEL SEP12b POSTFATIGUE

At the first stress level (113.3MPa), two selectively stitched panels, Sep12b and Sep15b, were tested. Panel Sep12b failed at 104 cycles, and panel Sep15b failed at 6954 cycles. The failure of both panels resulted from the cracks extending from the impacted stiffener, as shown in figures 38 and 39.

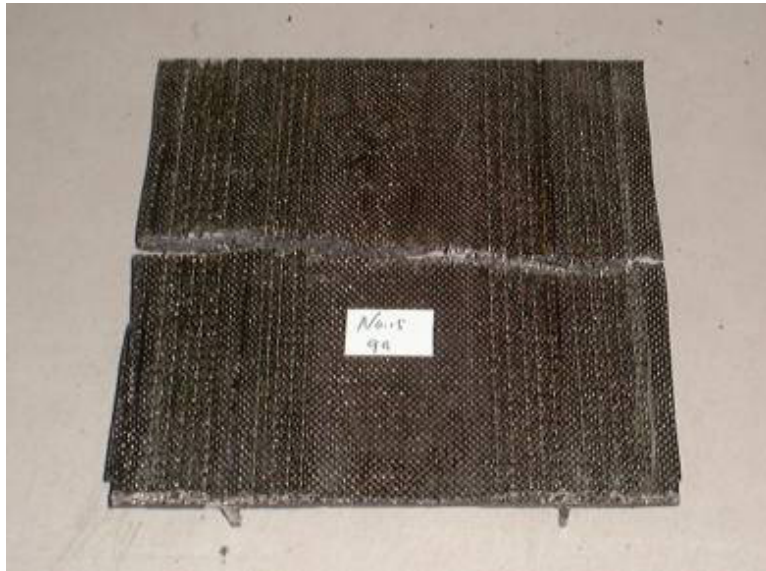
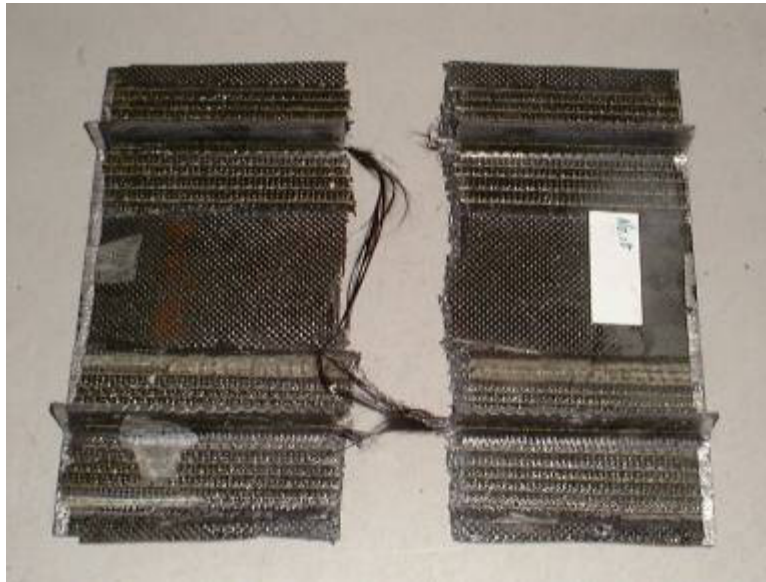
FIGURE 40. PANEL SEP14a POSTFATIGUE

At the second stress level (108.9 MPa), two selectively stitched panels, Sep14a and Sep14b, were tested at loading frequencies of 0.5 Hz. Even though these two panels were from the same batch, failure occurred at a fatigue life of 489 and 2879 cycles for panel Sep14a and Sep14b, respectively. As shown in figures 40 and 41, both panels had similar impact damage with a straight line crack through the stiffener height. Also, both panels exhibited the same failure mode with a crack line across the panel in the midsection. However, panel Sep14a had an under-infiltrated filler region that may have induced an early failure compared to panel Sep14b.

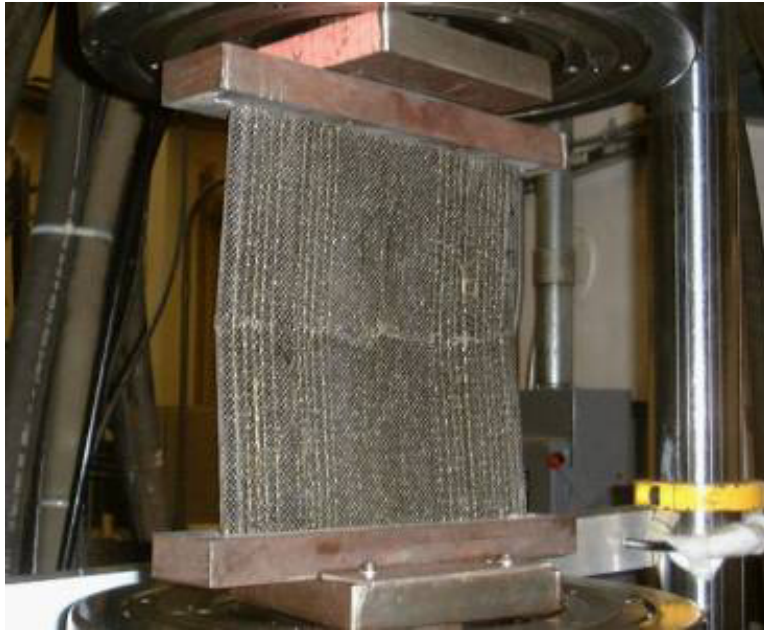
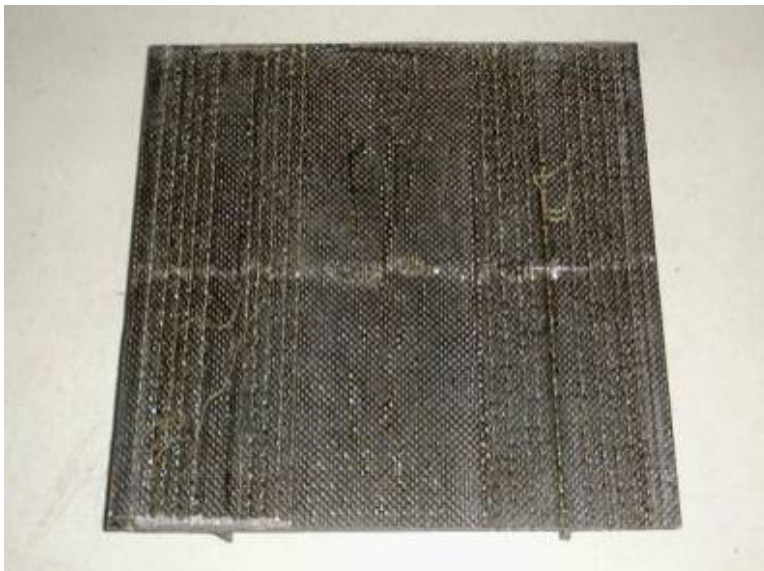
FIGURE 41. PANEL SEP14b POSTFATIGUE

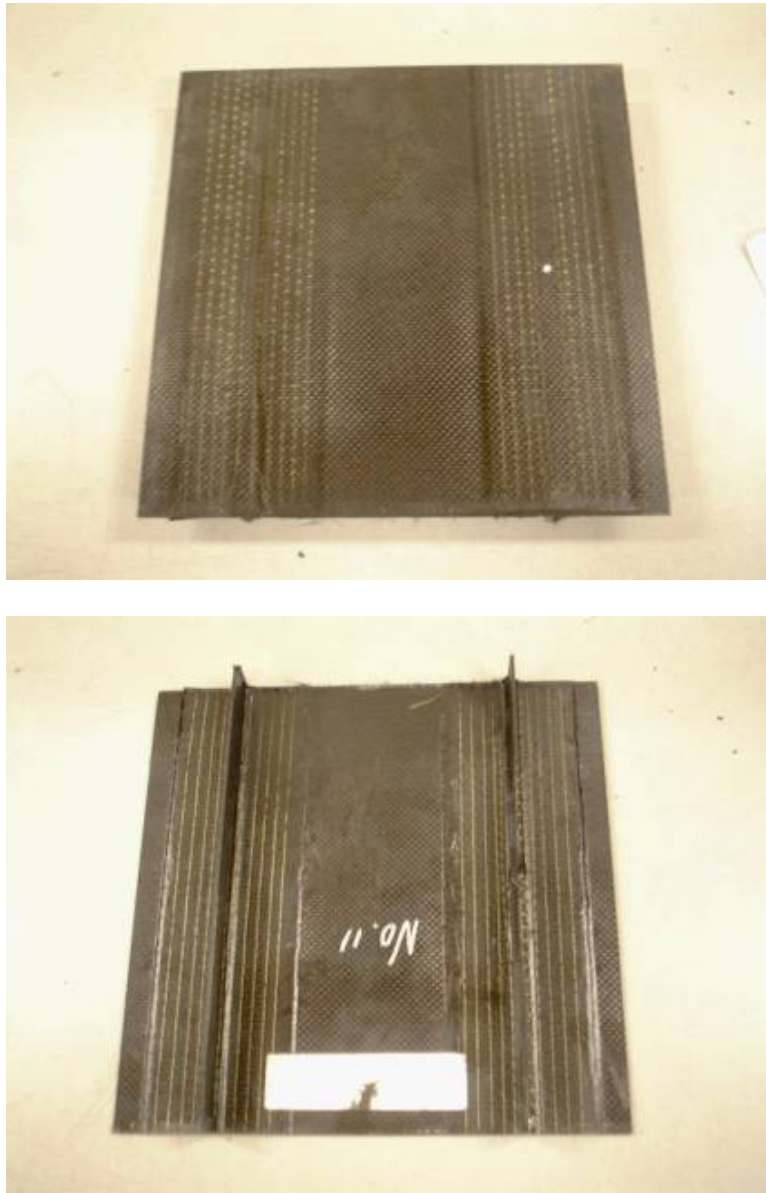
FIGURE 42. PANEL SEP11b POSTFATIGUE

At the third stress level (100.2 MPa), two selectively stitched panels, Sep11b and Sep17b, were tested. As figure 42 shows, panel Sep11b did not have a crack line extending from the impacted stiffener. The straight line crack through the stiffener had widened upon failure at 148,489 cycles. Panel Sep17b lasted 15,916 cycles. Both panels failed due to the impacted stiffener failure. However, panel Sep11b had less impact damage than panel Sep17b, as shown in figure 43.

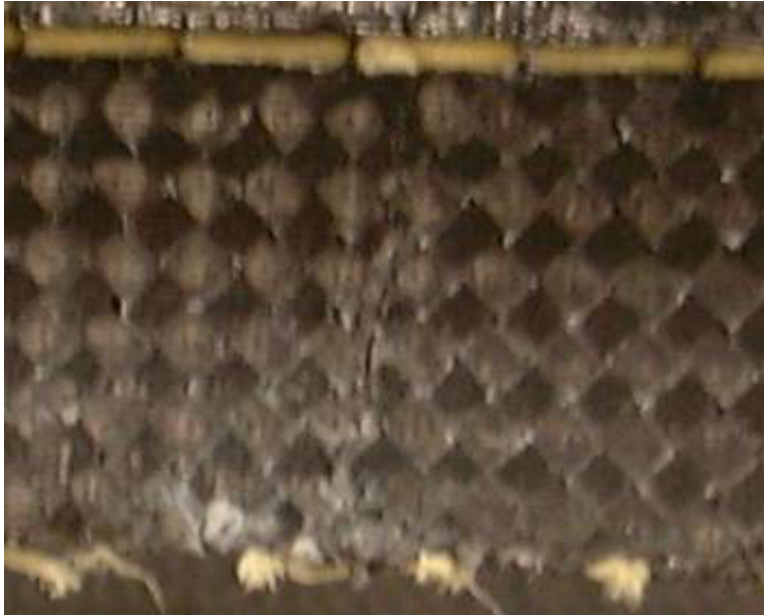
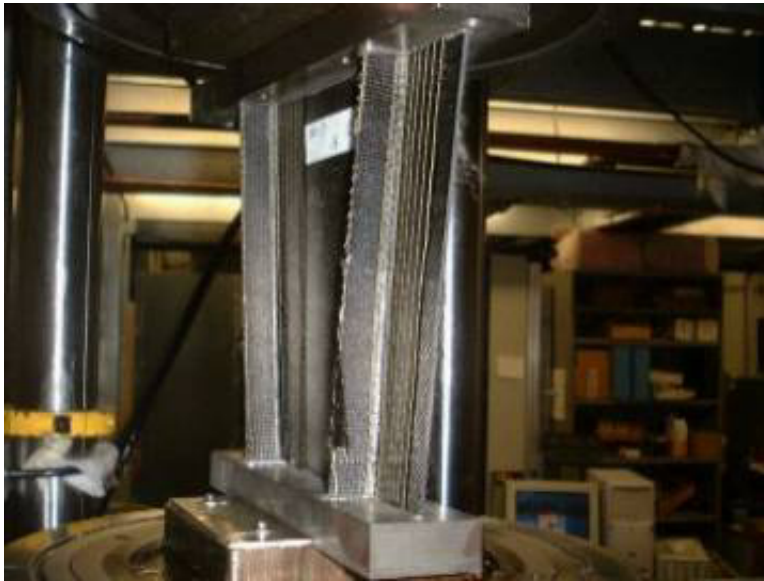
FIGURE 45. PANEL SEP6b POSTFATIGUE

At the fourth stress level (93.7 MPa), two selectively stitched panels, Sep13a and Sep6b, were tested. Again, the results of the two panels were quite different. Panel Sep13a was cycled up to 270,000 and denoted as a runout. The visual inspection of panel Sep13a indicates a visible crack line through the stiffener height, as shown in figure 44. A postimpact photo indicated that panel Sep6b had an angled crack line, as shown in figure 45. Panel Sep6b failed at 68,630 cycles due to an additional twist that caused the premature failure of the panel.

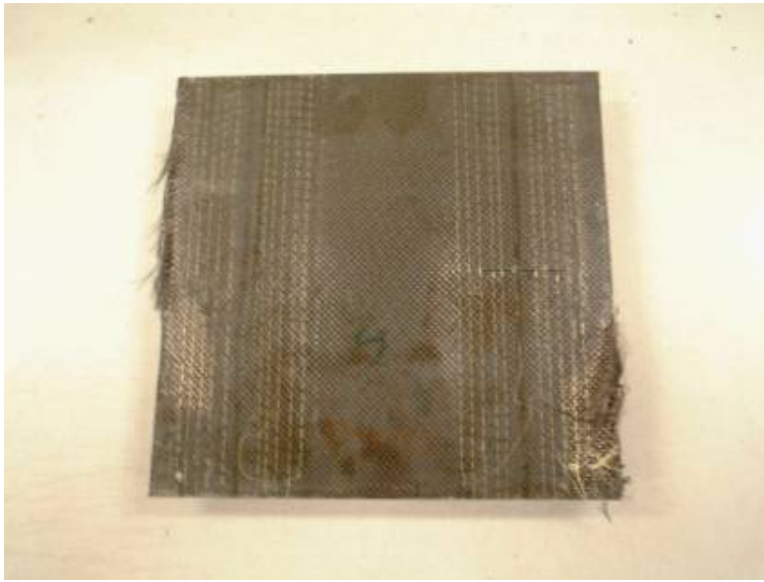
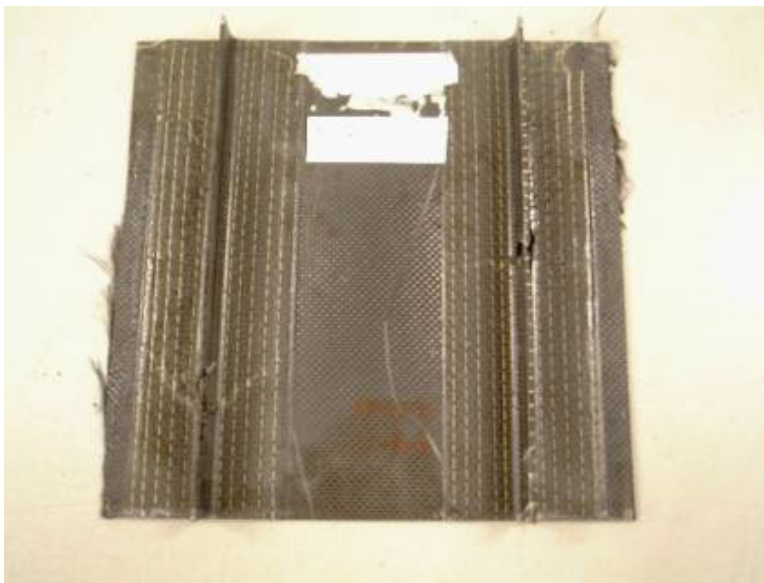
FIGURE 46. PANEL SEP12a POSTFATIGUE

At the fifth stress level (78.8 MPa), three selectively stitched panels, Sep12a, Sep15a, and Sep17a, were tested. Panel Sep12a failed at 6812 cycles. As figure 46 shows, panel Sep12a quality was particularly poor with some under-infiltrated regions on the edges of the panel. Hence, another panel was tested. Panel Sep17a failed at 58,793 cycles, and the failure originated from the damaged stiffener. Panel Sep15a lasted over 300,000 cycles and was denoted as a runout. A photo of panel Sep17a is shown in figure 47.
